Document ID	Title	Version	Release date
UP-501	Error in handling of QZSS SV194 Trimble Res SMT 360 Firmware v1.03 or earlier	1.05

## **TRIMBLE Resolution SMT 360 Multi-GNSS Receiver Error in handling of QZSS SV194 Firmware v1.03 or earlier**

### **Root Cause Analysis**

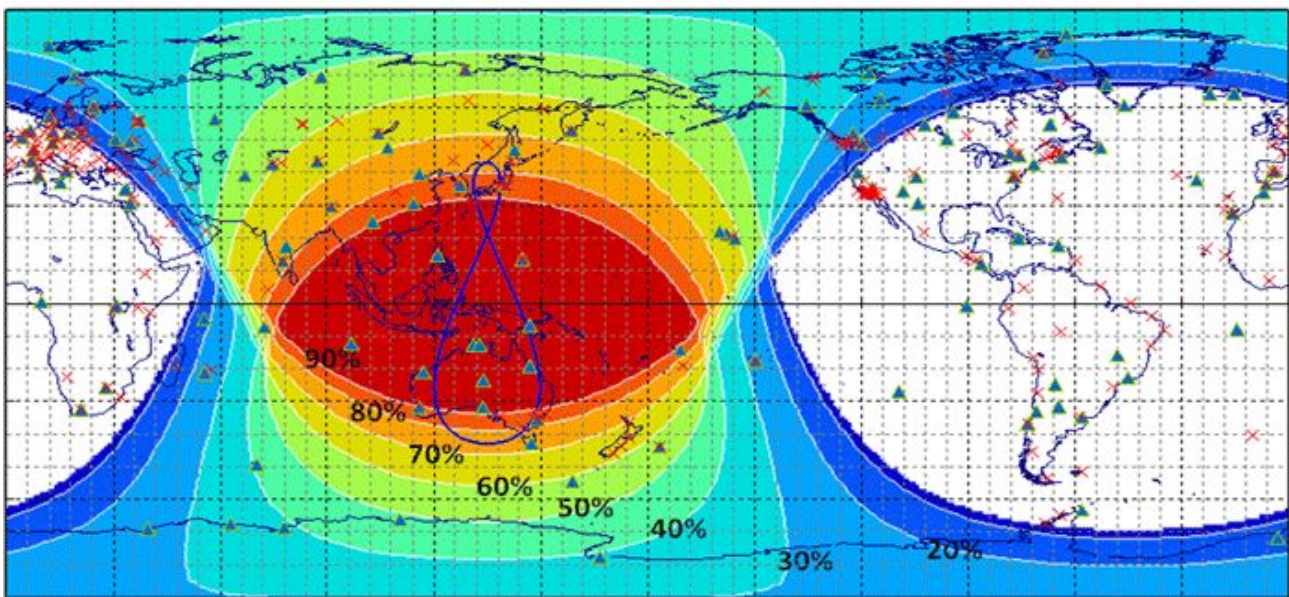
Trimble has announced that the Res SMT360 Multi-GNSS module's firmwares 1.01, 1.02 and 1.03 have a bug when operating in the visibility of the new QZSS (Japanese) satellite system. According to the orbits of the satellites their coverage will mainly affect GPS operations in

- South East Asia
- East Russia
- East China
- Australia
- West Pacific

regions, but can also extend to all other areas that are not colored white in the below graph.

- **Please contact us at [mail@planevision.de](mailto:mail@planevision.de) to obtain upgrade files and instructions.**
- **Please indicate your device serial number on contact.**
